# BULLETIN TECHNIQUE 2016 n°01

## 208 R2

08 janvier 2016

### Faisceau habitacle (prise afficheur MPDU) :

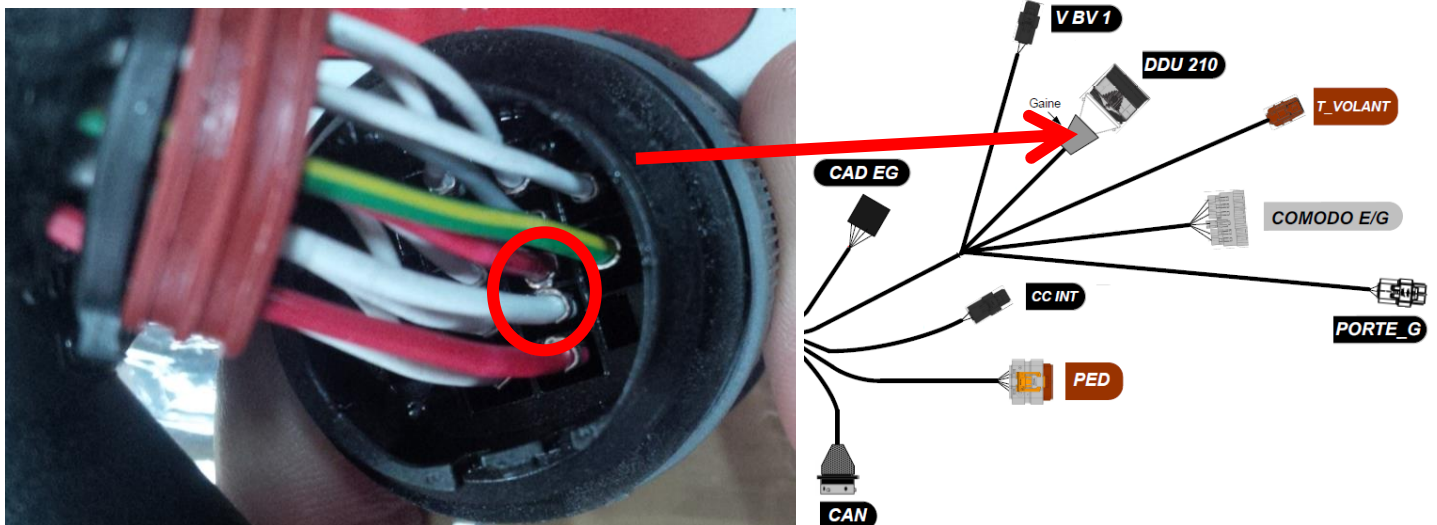
Suite à une erreur d'assemblage, certains faisceaux habitacle de référence 3Z9S21071 (jusqu'à l'indice E) peuvent être défectueux, et entraîner la destruction de l'afficheur MPDU.

Exemple de contact entre deux broches :

Si vous constatez une possibilité de contact entre 2 broches sur le faisceau habitacle de votre 208 R2, merci d'en informer l'assistance technique Peugeot Sport en joignant une photo.

Merci ensuite de nous retourner le faisceau en question avec :

Un nouveau faisceau habitacle conforme vous sera alors envoyé.

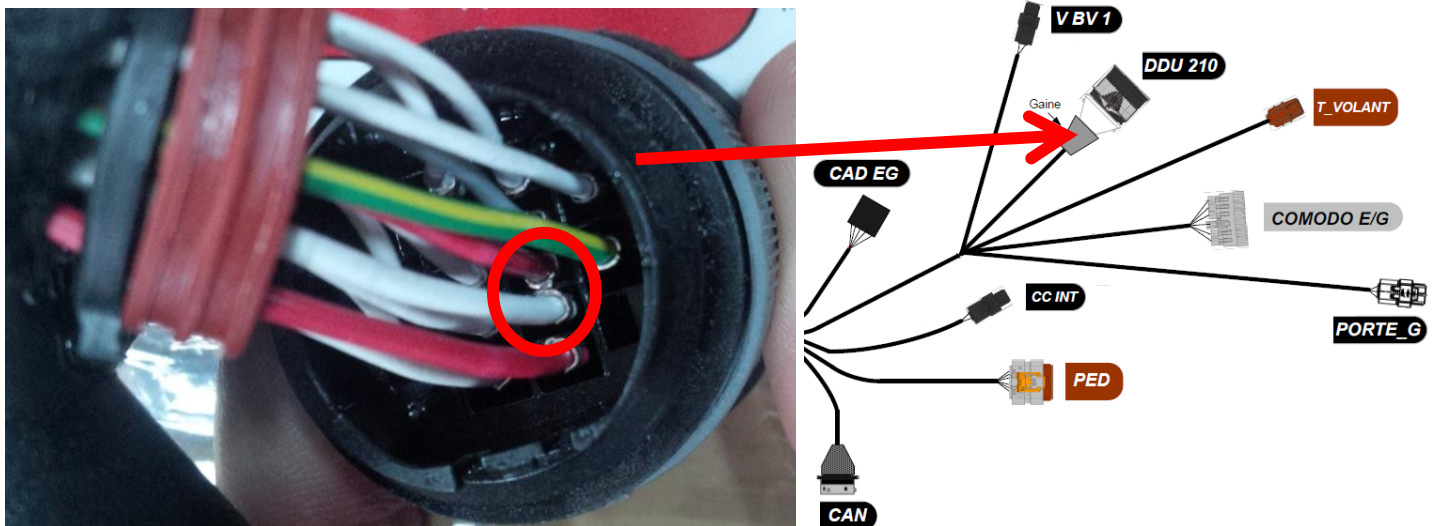
Following an assembly mistake, some cockpit wiring loom PN 3Z9S21071 (until spec letter "E") can be faulty and cause the destruction of the MPDU display.

Example of contact between two pins:

If you see any possibility of contact between two pins on the cockpit wiring loom of your 208 R2, thank you to inform the Peugeot Sport technical support and attach a picture of the problem.

Thank you then to send the faulty wiring loom to us together with:

A new cockpit wiring loom will then be sent to you.
