## BULLETIN TECHNIQUE 2014 n°4

### 208 R2

#### Colonne de direction

## TECHNICAL BULLETIN 2014 n°4

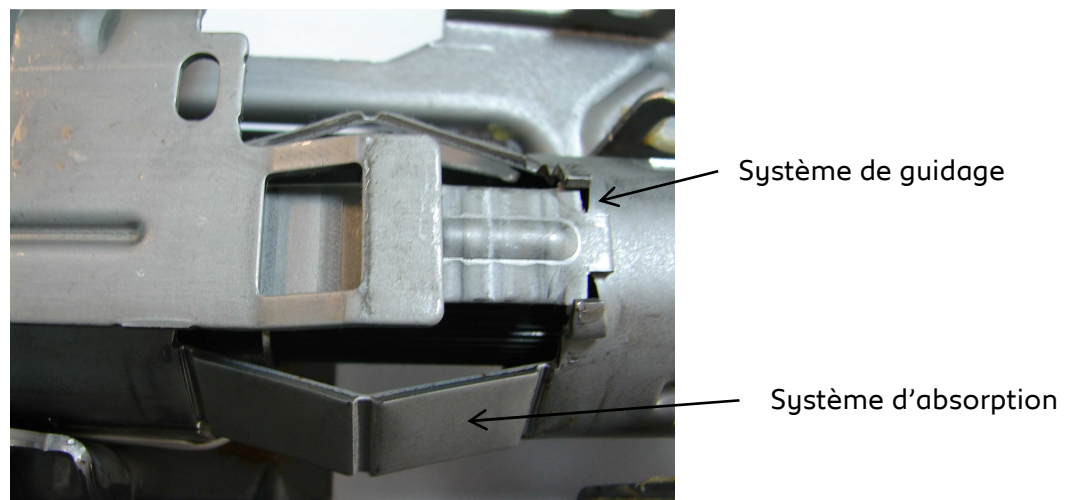
Le fourreau de colonne de direction, référence 1E4520176D, comporte un système d'absorption de chocs.

Nous vous rappelons qu'il est indispensable de contrôler régulièrement l'état de la colonne de direction, notamment suite à des chocs importants au niveau du train avant, et plus particulièrement des pièces d'absorption et de guidage représentées ci-dessous :

Il est indispensable de remplacer la colonne de direction si l'une de ces pièces est endommagée.

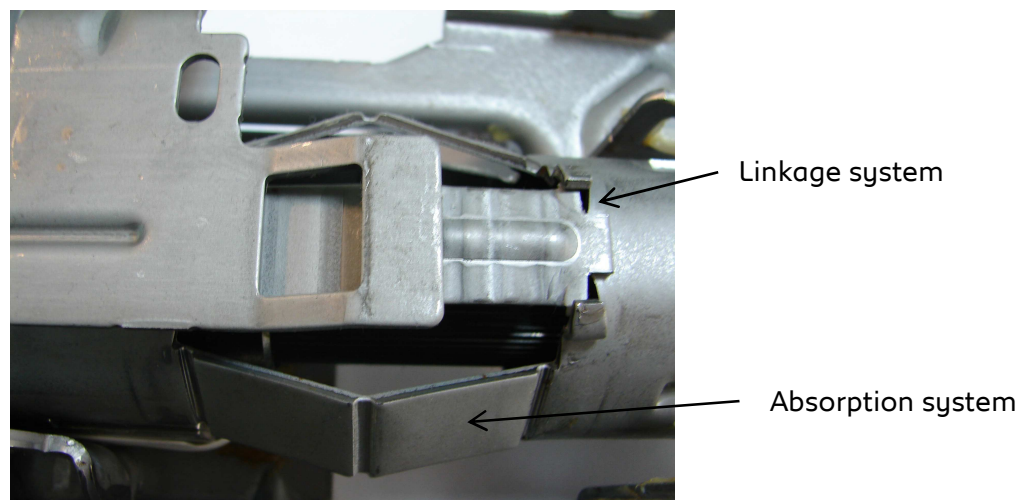
The steering column, reference 1E4520176D, includes a shock absorption system.

We remind you it is essential to control regularly the column and its absorption system to be sure it is not damaged, especially after important shocks with the front axle:

It is indispensable to replace the steering column if one of these parts is damaged.
