BULLETIN TECHNIQUE 2015 n°03

208 T16

14 janvier 2015

Roulement galet tendeur de courroie accessoire (réf. PS89725A10)

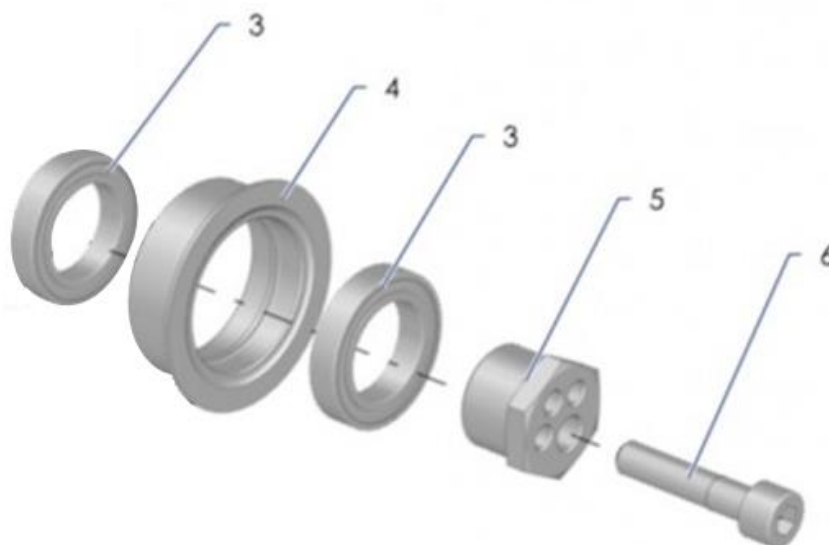
Suite à une erreur d'approvisionnement des roulements de galet tendeur de courroie d'accessoire (repère 3 sur l'image ci-dessous, référence PS89725A10), nous vous prions de bien vouloir contrôler la couleur des bagues d'étanchéité plastique de ces roulements.

En effet, **les roulements conformes ont des bagues d'étanchéité en plastique de couleur verte alors que celles des roulements non conformes sont de couleur noire.**

L'utilisation de ces roulements « noirs » peut entraîner la rupture rapide de la pièce, la perte de la courroie d'accessoire et des dégâts non-négligeables sur votre moteur.

Merci donc de nous envoyer les roulements « noirs » qui font partie du lot non-conforme en votre possession accompagnés de ce bulletin technique : dès réception, nous les échangerons avec des roulements « verts » conformes.

De plus, nous vous informons que la **préconisation de remplacement de ces roulements** de galet est modifiée à **500 kilomètres** d'E.S. et de test au lieu de 1000 kilomètres précédemment, et qu'un contrôle de l'état et du jeu dans le roulement doit être effectué après chaque rallye.

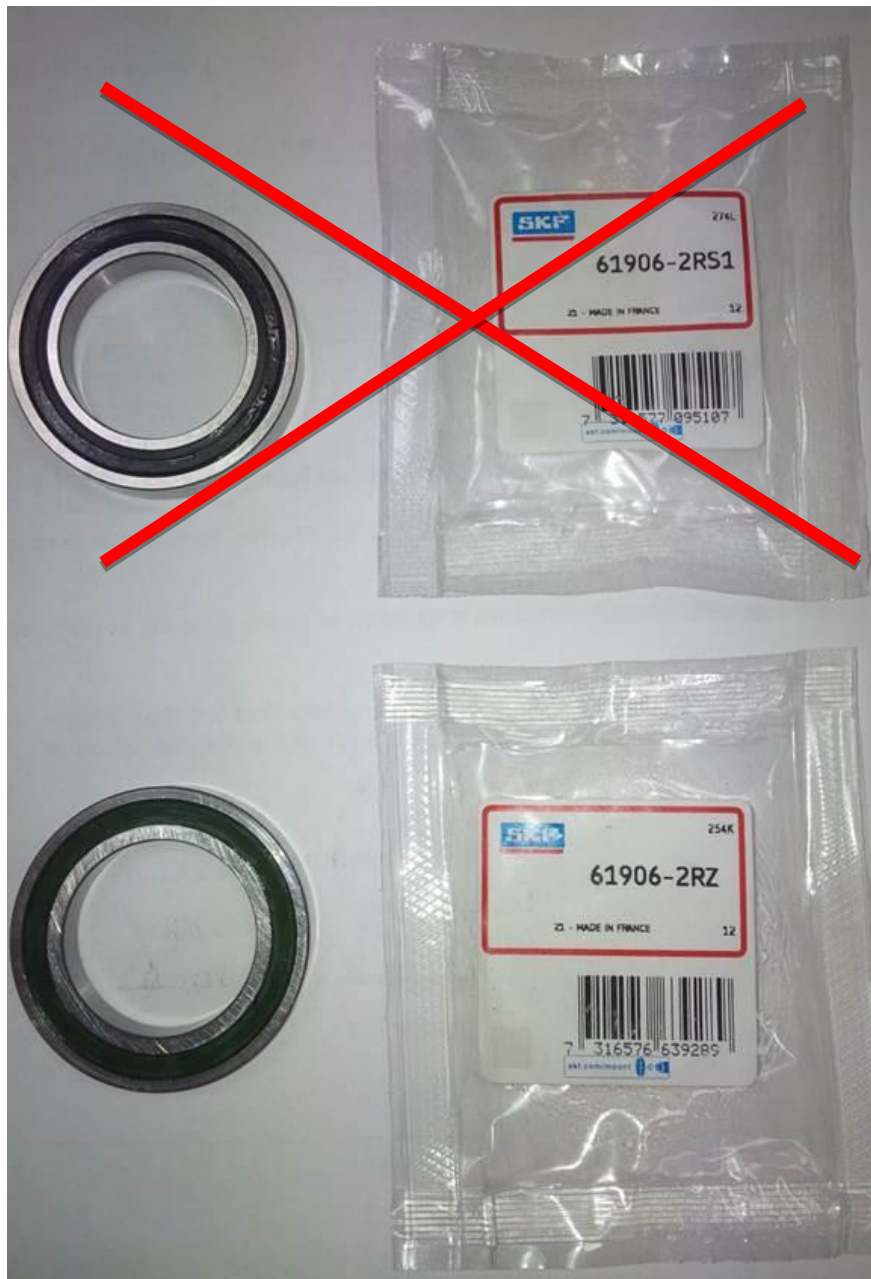
Références SKF :

La référence du roulement non-conforme avec bagues plastiques noires est :
SKF 61906-2RS1

La référence du roulement conforme avec bagues plastiques vertes est :
SKF 61906-2RZ

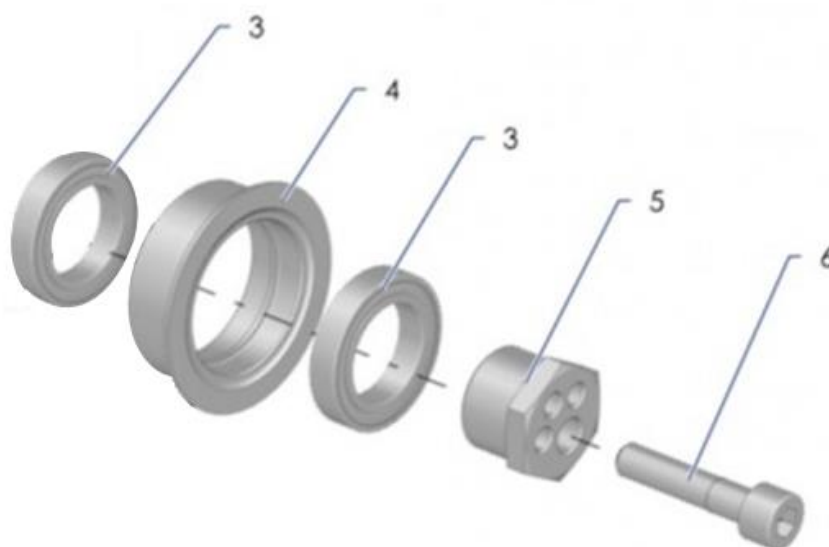
Due to a supply error on the accessory belt tensioner bearing (item 3 on the picture below, part number PS89725A10), we could have provided a wrong batch of bearings. Thus, thank you to check the color of the plastic sealing rings of these bearings.

As a matter of fact, **the correct bearings have green plastic sealing rings while those which are not correct have black plastic sealing rings.**

The use of these "black" bearings can lead to the fast breaking of the parts, the loss of the accessory belt and then damages the engine.

Please send us back the "black" bearings you may have, together with a copy of this technical bulletin: as soon as we receive them, we will send "green" bearings to you.

Furthermore, we inform you that the **replacement mileage recommendation** of these bearings is now **500 kilometers** of stage and tests (instead of 1000 km previously). And we recommend you to check your bearings after every rally.

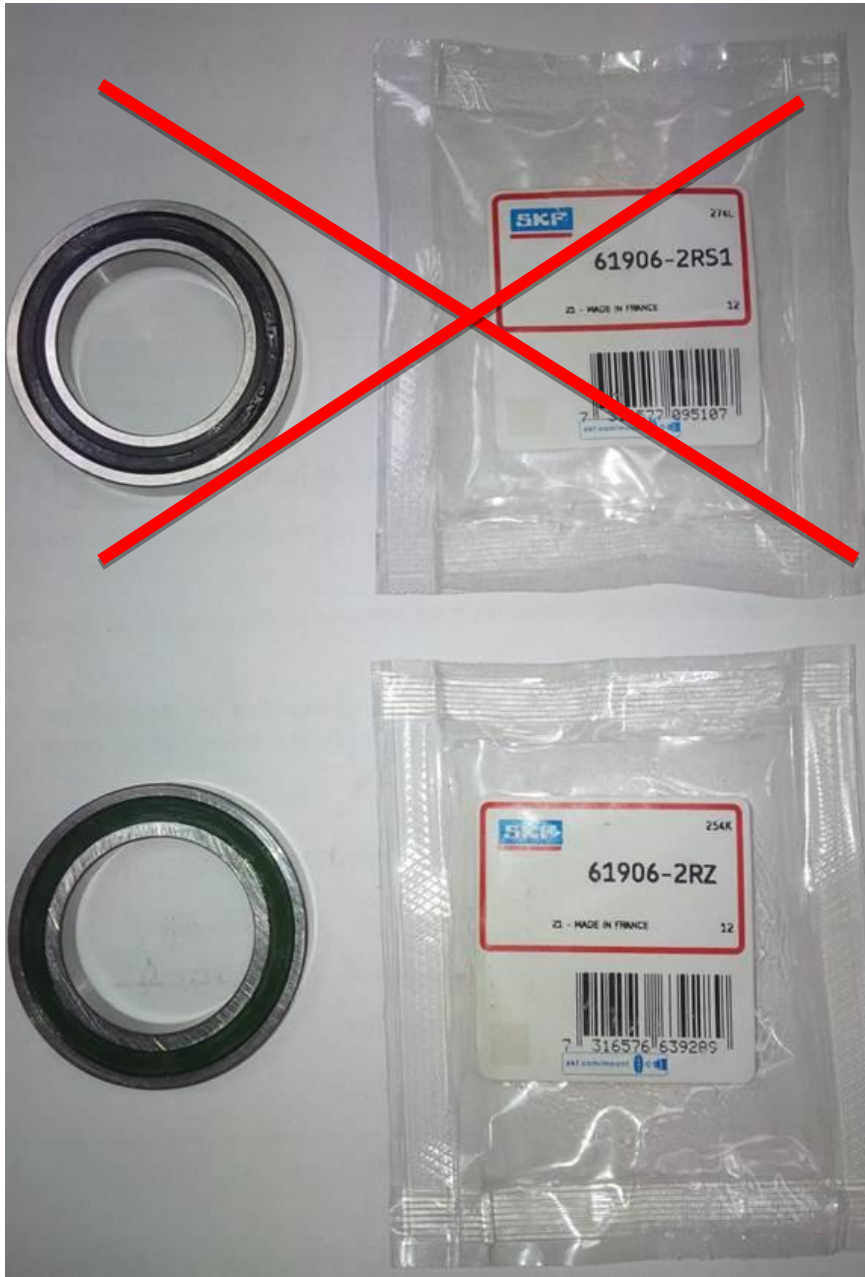
SKF part numbers:

Part number of the
wrong bearing with
black plastic sealing
ring:
SKF 61906-2RS1

Part number of the
good bearing with
green plastic sealing
ring:
SKF 61906-2RZ
